# Manhole Inspection Summary

Manhole # S29I\_\_031MH

Insp Date: **9/8/08 1:42 PM**

**Location** Address: **105 Penn St**

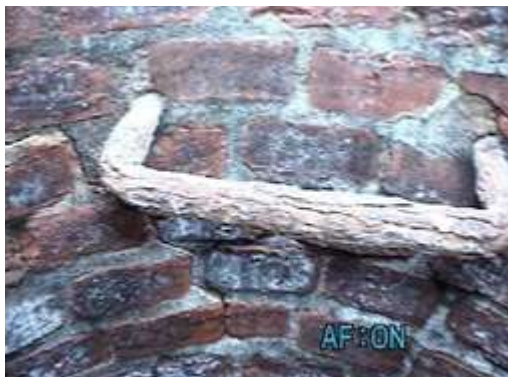
Miscellaneous

Count: **9** Missing: **0** ☒ **Corroded**

corroded step

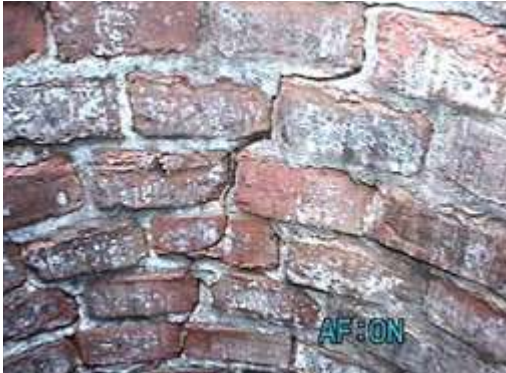
Defect 5

Condition: ☐ Sound ☒ **Cracked** ☐ Root Intrusion ☐ Loose Brick ☐ Deteriorated

cracked bricks and mortar in corbel

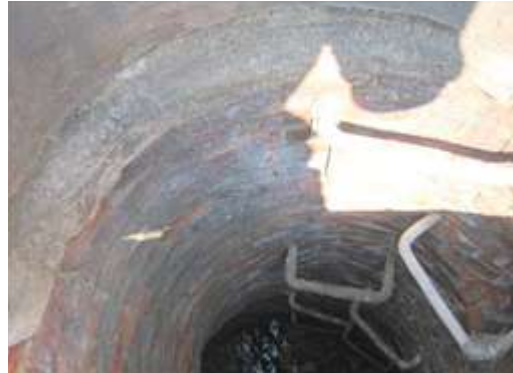
Defect 4

Offset: **2** (in.)

frame offset 2"

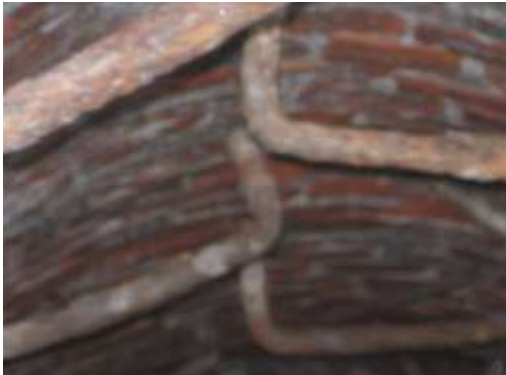
Defect 3

corroded steps

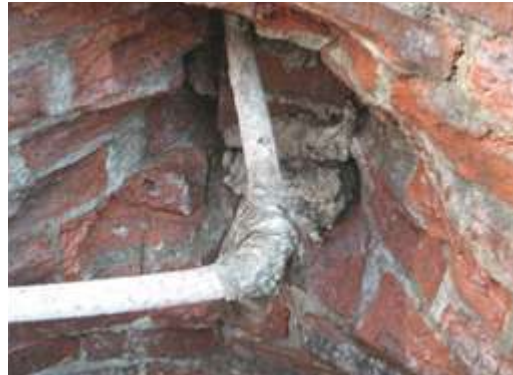
Defect 2

☒ **Evidence Of Surcharge** Depth: **4** (ft.) ☐ Active Surcharge Present

evidence of surcharge/deterioration of bricks

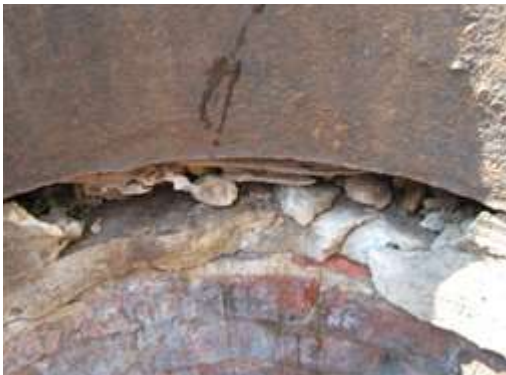
Defect 1

Condition: ☐ Sound ☐ Cracked ☐ Root Intrusion ☒ **Loose Brick** ☒ **Deteriorated**

deterioration under frame

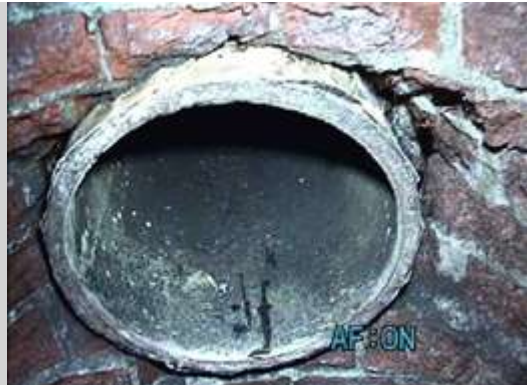
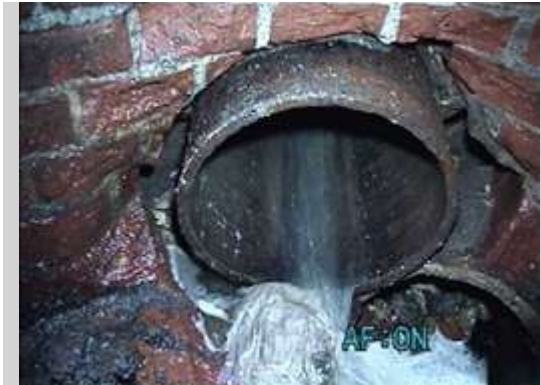
8 O'Clock Inflow

Drop: **Inside** **Direct**

Angled: **Yes** Reading: **9.99** (ft.)

Inv Depth: **10.99** (ft.)

Drop Condition: **Open**

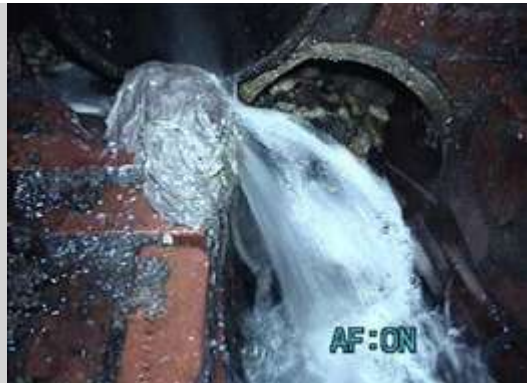
9 O'Clock Inflow

Connects To: **Stub connection / abandoned**
